# Scanning Electron Microscopic Analysis of the Screw Threads of Loosened and Fractured Abutments: A Case Report

This case report involved an evaluation of the screw threads of a loosened abutment compared with those of a fractured abutment removed from the same patient by Scanning Electron Microscopy (SEM). According to the results of the SEM analysis, deformities in the screw threads of the loosened abutment were evaluated, and whether a loosened abutment should be rescrewed was considered.

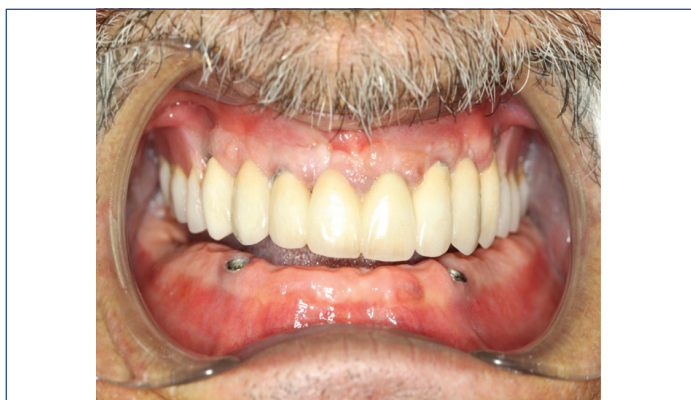
Upon clinical examination, the patient had a mandibular overdenture supported by two implants at tooth #33 and #43 regions with locator attachments [Table/Fig-1]. In the upper jaw, there was a precision attachment removable denture supported by implant supported fixed prostheses. The implants were placed at tooth #12, #14, #22, and #24 regions. The screw of the locator abutment at tooth #33 region was fractured and the screw of the locator abutment at tooth #43 region was loosened.

**[Table/Fig-1]:** Intraoral view. The patient had a precision attachment removable denture supported by implant-supported fixed prostheses in the upper jaw, and an implant-supported overdenture with locator attachments in the lower jaw.

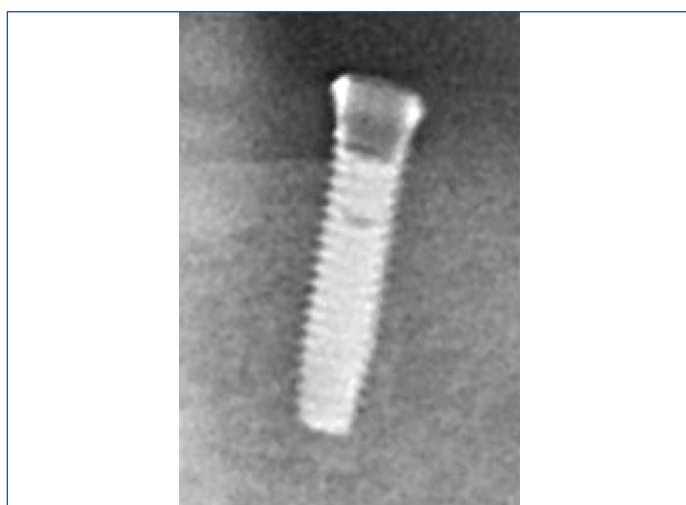
A periapical radiograph was taken, which, together with a clinical examination, showed that the locator abutment at tooth #33 region was fractured on first thread of the screw [Table/Fig-2]. The fractured part of the screw was still inside the implant. The other locator abutment at tooth #43 region was also loosened. The fractured screw was successfully removed using an ultrasonic instrument [Table/Fig-3].

**[Table/Fig-2]:** Radiograph of tooth #33 region. A fractured abutment screw is evident.

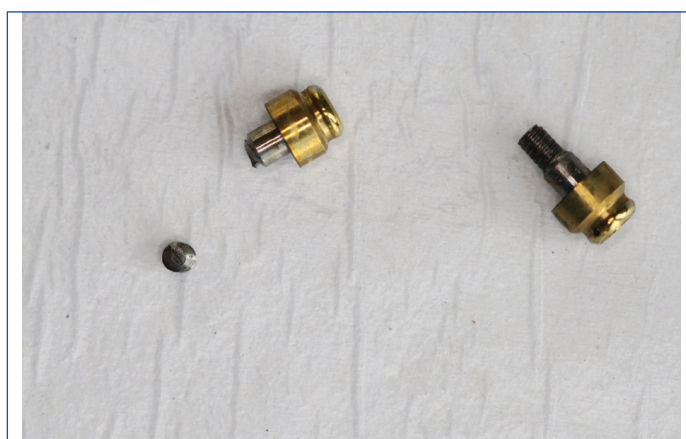
**[Table/Fig-3]:** Images of the fractured and loosened abutments.

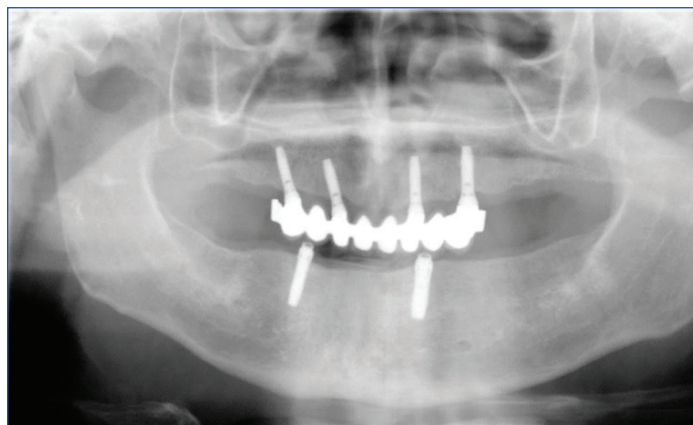
[Table/Fig-4]: Panoramic radiograph taken at the 5-year follow up examination.

Additionally, the occlusion of the dentures was controlled and bilaterally balanced occlusion was obtained. No problems were noted at 0.5-, 1-, and 5-year follow up examinations [Table/Fig-4].

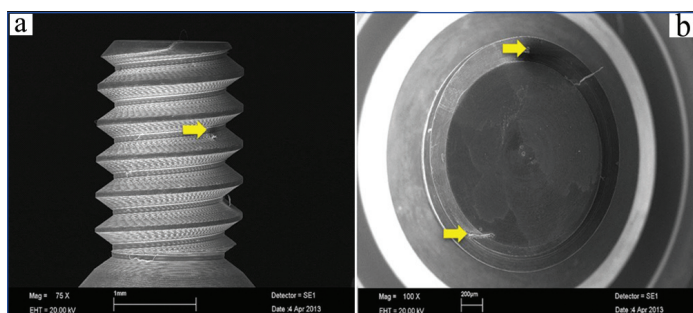
Screw threads of the unused abutment: No macroscopic alterations or deformations were observed. No alterations or deformations in the convexities of the screw thread were present, but some irregularities were noted [Table/Fig-5a,b].

[Table/Fig-5a,b]: Scanning electron micrographs (magnification: 75× and 100×, respectively) of an unused abutment screw showing some irregularities (arrows).

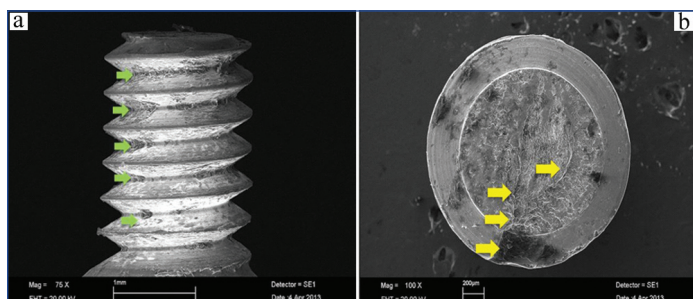
Screw threads of the loosened abutment: Several alterations and deformations were evident in the concavities and convexities of the screw threads of the loosened abutment. The thread appeared deformed in the concavities more than the convexities. The metal structure appeared strained without any cracks. Fractures progressing horizontally from the convexities of the screw to the inner parts were noted [Table/Fig-6a,b].

[Table/Fig-6a,b]: Scanning electron micrographs (magnification: 75× and 100×, respectively) of a loosened abutment screw. Green arrows, deformed thread convexities. Yellow arrows, fractures progressing horizontally from the convexities of the screw to the inner parts.

The previous studies about loosened abutment screws showed that using a loosened abutment screw can increase the risk of fracture of the abutment [10-12]. In this case report numerous alterations and deformations were evident in the concavities and convexities of threads in the loosened and fractured screws. In agreement with the findings of Scarano A et al., macroscopic differences were observed between the unused abutment screw and the loosened and fractured abutment screws [10]. There were some irregularities on the surface of the unused abutment screw, and fractures progressing horizontally from the convexities of the thread to the inner parts were noted in the loosened abutment screw.

In conclusion, it was observed that a loosened abutment screw can lead to fracture, according to the deformations in its structure. For this reason, changing the loosened abutment screws with the new ones will help to reduce the fracture risk. In addition to these, torqueing the abutment screw at the requested torque is important.

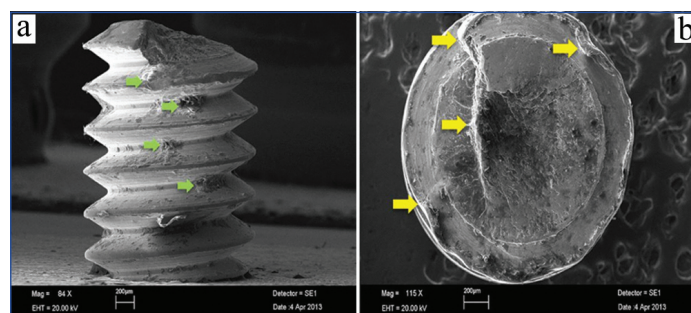
In the screw threads of the fractured abutment: SEM of the fractured abutment showed a fracture at the junction of the first screw thread and the shoulder of the abutment. Many alterations and deformations were present in the concavities and convexities of the screw threads of the fractured abutment. The thread appeared deformed in the convexities more than the concavities, in contrast

to the loosened abutment. The metal structure in the convexities appeared strained with small cracks present at grain boundaries. Crack growth appeared to be related to the high number of crack coalescence events. There was increased fragmentation at the fracture site [Table/Fig-7a,b].

[Table/Fig-7a,b]: Scanning electron micrographs (magnification: 75× and 100×, respectively) of a fractured abutment screw. Green arrows, deformed thread convexities. Yellow arrows, crack growth related to the high number of crack coalescence events. There was increased fragmentation at the fracture site.

In the patient, the main problem was a non conforming indication. In the upper jaw, the denture was supported by implant supported fixed prosthesis on four implants; in contrast, the mandibular overdenture was supported by two implants with stud attachments. Another possible explanation for the fracture was unrecognised screw loosening due to non axial or excessive prosthetic loading, poor denture support, poor balance, or occlusal rocking. After the new abutments were placed the occlusion of the dentures was controlled and bilaterally balanced occlusion was obtained in order to prevent any loosening in the future.

The cause of implant failure can be determined by checking the occlusion, eliminating premature contacts, and equilibrating the chewing force [6,7,9]. A detailed clinical examination should be performed to identify parafunctional activities, including bruxism, which may cause component fractures [9]. The patient can use his/her overdentures without any problem if such factors are eliminated.
