Retrieval of Separated Instruments from Root Canal Space: A Case

MUSTAFA HUSSEIN AL-ATTAS¹, SAAD ABDULAZIZ AL-NAZHAN², MUHANNAD SALEM AL-HARBI³

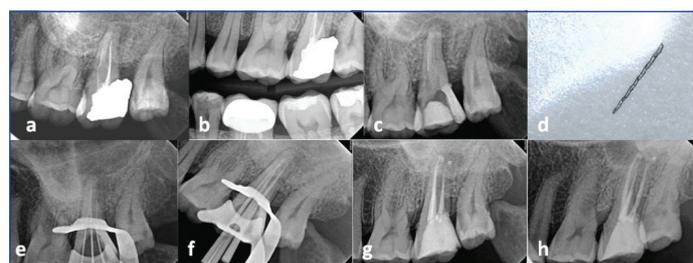
[Table/Fig-1]: a) pre-operative periapical radiograph showing the separated instrument in the mesial root; b) Bitewing radiograph of the left side. (c) Glass Ionomer build-up and removal of old gutta-percha; d) image of the retrieved instrument; e) Determination of working length; f) Master cone selection; g) Postoperative periapical radiograph; h) 6 months follow-up periapical radiograph.

A 40-year-old female patient was referred from the Restorative Department clinic for root canal retreatment of the maxillary left second molar (#27) due to defective amalgam restoration and poor root canal treatment. The patient reported to the restorative clinic for routine checkup. The medical history was unremarkable. The molar had undergone a root canal treatment five years back. On clinical examination, it was noted that tooth #27 had a defective amalgam restoration. It was not tender to percussion or palpation and there were no signs of mobility or periodontal affection. Radiographic examination of the tooth showed a poor/unacceptable root canal treatment with apical radiolucency and separated file located apically in the Mesiobuccal (MB) canal [Table/Fig-1a]. An overhanging amalgam restoration was noticed [Table/Fig-1b]. The tooth was diagnosed with asymptomatic

apical periodontitis [15]. Informed consent was obtained from the patient prior to the retreatment. Root canal retreatment was initiated, with removal of the old amalgam restoration and building up of the tooth with Glass ionomer cement (GIC) (Fuji IX GP[®]; GC, Chicago, IL, USA) to allow rubberdam isolation [Table/Fig-1c]. Next, an access cavity was created under the rubberdam isolation using a Dental operating microscope (DOM) (OPMI Pico; Zeiss, Oberkochen, Germany) and three canals were identified. The old gutta-percha was removed using Protaper retreatment files (Dentsply Maillefer, Ballaigues, Switzerland). A staging platform was created using a Gates Glidden bur (size #2; Dentsply-Maillefer) to expose the tip of the separated fragment in the MB canal, and an ultrasonic tip (Satelec/Acteon, Merignac, France) was then used intermittently at medium frequency (36 kHz) without simultaneous coolant irrigation to successfully retrieve the instrument fragment [Table/Fig-1d]. The working length was determined radiographically [Table/Fig-1e] and the canal was prepared using the Protaper Next system (Dentsply Maillefer) to size X3, with copious irrigation of 5% NaOCl solution followed by 17% EDTA. The canals were dried and filled with gutta-percha and sealer cement (AH26 sealer; Dentsply Detrey GmbH, Konstanz, Germany) using System B (Courtesy SybronEndo, Orange, CA, USA) and Hotshot (Discus Dental, Culver City, CA, USA) devices [Table/Fig-1f,g]. The access cavity was immediately sealed with GIC and then replaced one week later by a composite restoration (GC America, Chicago, IL, USA). The patient was referred back to the Restorative Department for crown restoration. She decided to delay the crown due to financial reason. At the six-month follow-up visit, the tooth was clinically asymptomatic and radiographs showed that the lesion had reduced in size [Table/Fig-1h].

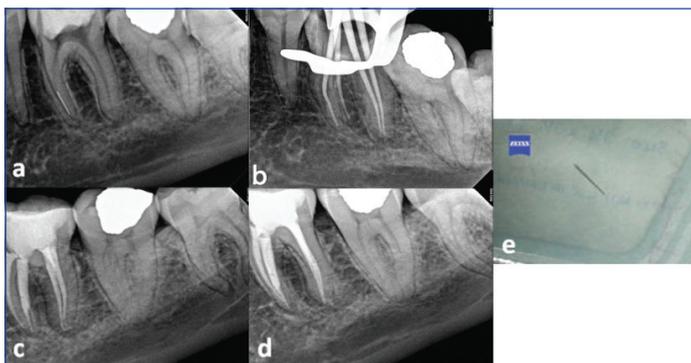
[Table/Fig-2]: a) Preoperative periapical radiograph of tooth #36; b) shows gutta-percha master cone trial; c) Postoperative radiograph; d) Follow-up radiograph; e) The retrieved instrument.

A 30-year-old female patient with an unremarkable medical history was referred by a general dentist to the endodontic clinic for retrieval of an instrument that had accidentally separated during root canal treatment of the mandibular left first molar (#36) one week back. The dentist had decided not to continue the treatment due to separation of an X1 file in the MB canal and referred the case to specialised endodontic clinic with a microscope and better facilities. On clinical examination, tooth #36 was tender to percussion with no signs of mobility or periodontal infection. Radiographs showed widening of the Periodontal ligament (PDL) at the apex of the mesial root and a separated file located apically in the MB canal [Table/Fig-2a]. Symptomatic apical periodontitis was diagnosed. Root canal treatment of the involved tooth was initiated under rubberdam isolation and DOM magnification. A glide path was prepared carefully by gate glidden bur sizes 2 and 3 from the canal orifice to the tip of the separated instrument then an ultrasonic tip was used to remove it. The separated file was retrieved and the canals were prepared and filled with gutta-percha and AH26 sealer cement using System B and Hotshot devices [Table/Fig-2b,c]. The six-month follow-up revealed no clinical symptoms or radiographic apical abnormalities [Table/Fig-2d]. [Table/Fig-2e] shows the retrieved instrument.

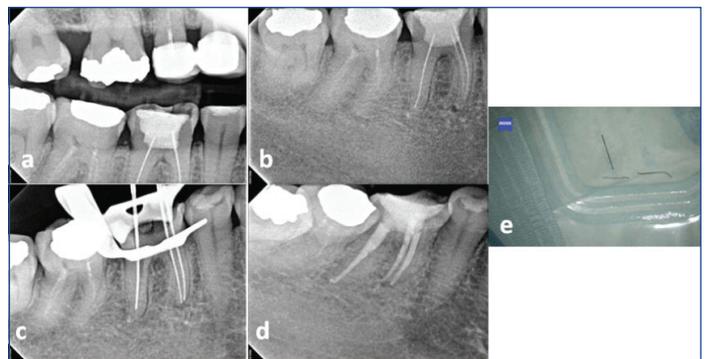
[Table/Fig-3]: a) Bitewing radiograph of the right side; b) Preoperative periapical radiograph of tooth #36; c) Working lengths determination; d) Postoperative radiograph; e) The retrieved instrument.

A 41-year-old female patient, in good health, was referred from the Restorative Department for root canal retreatment of the mandibular right first molar (#46). She was having pain on chewing in tooth #46 since last two days. The tooth had undergone previous endodontic treatment nine years ago. On clinical examination, the involved tooth was tender to percussion and palpation, with no signs of mobility. The radiographic examination showed a previous poor/unacceptable root canal treatment and three separated files (two in the mesial root and one in the distal root) and a widened PDL space [Table/Fig-3a,b]. The patient was diagnosed with symptomatic apical periodontitis. The rubberdam was applied and access was established under DOM. The three separated files were successfully removed using an ultrasonic tip vibrating intermittently at medium frequency (36 kHz) without simultaneous coolant irrigation. The working length was determined using Root ZX apex locator (J. Morita Co., Kyoto, Japan) and confirmed with periapical radiograph taken with mesial shift [Table/Fig-3c] and all canals were cleaned and shaped using a Protaper Next system with NaOCl 5% irrigation. The canals were flushed with EDTA 17% and then dried and obturated with gutta-percha and AH26 sealer cement using System B and Hotshot devices [Table/Fig-3d]. The access cavity was temporarily sealed and the patient was referred back to

the Restorative Department for final restoration. [Table/Fig-3e] shows the retrieved instrument.

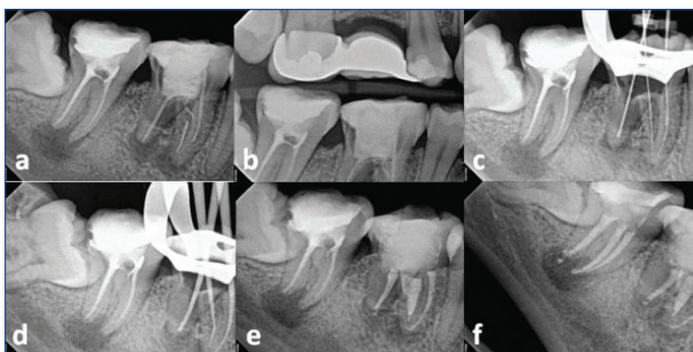
[Table/Fig-4]: a) Preoperative periapical radiograph of teeth #46 & #47; b) Bitewing radiograph of the right side; c) Working lengths determination of tooth #46; d) Master cone selection; e) Postoperative radiograph of tooth #46; f) Postoperative radiograph of both teeth #46 and #47.

A 31-year-old male patient was referred from the Restorative Department for root canal retreatment of the mandibular right first (#46) and second (#47) molars. The patient complained of pain on chewing in the right posterior tooth region since the last three days. The medical history was unremarkable. The molars had undergone root canal treatment 3 years back. On clinical examination, tooth #46 was tender to percussion and palpation, whereas tooth #47 was not tender to percussion. A radiographic examination showed a previous poor/unacceptable root canal treatment with apical radiolucency of both teeth and separated instrument in the Mesiolingual (ML) canal [Table/Fig-4a]. Tooth #46 showed radiolucency at the furcation area [Table/Fig-4b] and was diagnosed with symptomatic apical periodontitis, while tooth #47 was diagnosed with asymptomatic apical periodontitis. The patient was referred to surgery clinic for extraction of third molar tooth (#48). Both teeth (#46 and 47) were retreated under rubberdam isolation. The old gutta-percha was removed using ProTaper retreatment files (Dentsply Maillefer, Ballaigues, Switzerland) under DOM. The furcation perforation was repaired with mineral trioxide aggregate (MTA) (Dentsply Tulsa Dental, Tulsa, OK, USA). The ML canal was overflared due to a previous attempt to remove the separated file. There was no need to create a staging platform since the fragment was clearly visible. The instrument fragment was successfully retrieved using an ultrasonic tip vibrating intermittently at medium frequency (36 kHz) without simultaneous coolant irrigation. The working length was determined [Table/Fig-4c], and all canals were cleaned and shaped using the Protaper Next system and then flushed with 5% NaOCl solution and 17% EDTA. Canals were filled with gutta-percha and AH26 sealer cement using System B and Hotshot devices [Table/Fig-4d,e]. Root canal treatment was performed for tooth #47 in another visit [Table/Fig-4f]. The access cavities were temporarily sealed and the patient was referred back to the Restorative Department for final restoration. The 48 tooth was planned for extraction but the patient missed the appointment in the surgical clinic. Patient was given an appointment for follow-up, but he did not show-up.
