# A Technique Elucidating the Retrieval of an Adhered Cover Screw in a Dental Implant – A Case Report

## CASE REPORT

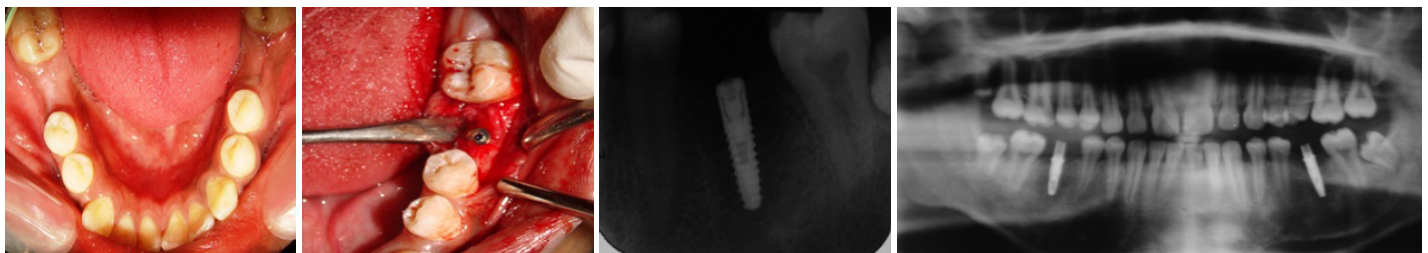
[Table/Fig-1]: Edentulous region 46,36

[Table/Fig-2]: After implant placement in 36

[Table/Fig-3]: Post-operative radiograph

[Table/Fig-4]: Radiograph showing Abutment fixed in 36,46

A 20-year-old male patient reported to the Department of Periodontology & Oral Implantology with the complaint of missing teeth in lower back teeth region. On thorough clinical and radiological evaluation of edentulous space in relation to 36 and 46, it was decided place two 2-piece implant\* (4.2 x 13 mm) in both the sites [Table/Fig-1 and 2]. [Table/Fig-3] radiograph showing implant in 36 region.

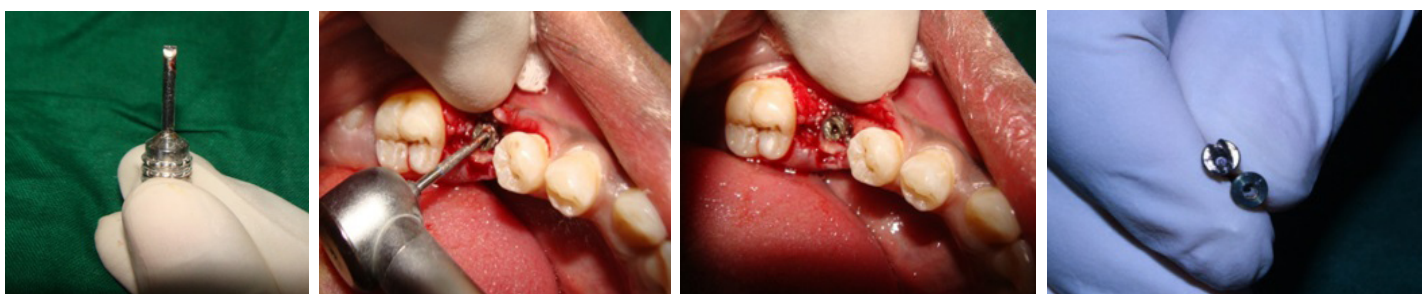
[Table/Fig-5]: Hex driver used to remove the cover screw

[Table/Fig-6]: Groove is made using a tapering fissure bur

[Table/Fig-7]: Cover screw with groove

[Table/Fig-8]: Cover screws

was attached to implant in relation to 46 [Table/Fig-4]. Difficulty was encountered in unscrewing the cover screw of implant in relation to 36 with a hex driver (1.22S) and the driver started to slip in the hex slot of the cover screw [Table/Fig-2 and 3]. Decision was made to make a straight slot on the cover screw to engage the straight screw driver (1.22L) [Table/Fig-5]. The slot was made by grooving the cover screw with a diamond tapering fissure bur [Table/Fig-6]. The cover screw was retrieved easily using the straight screw driver [Table/Fig-7]. The retrieved cover screw [Table/Fig-8]. After removal of cover screw [Table/Fig-9]. The abutment was placed in 36 and 46 [Table/Fig-10 and 4] & implant restored to function [Table/Fig-11].

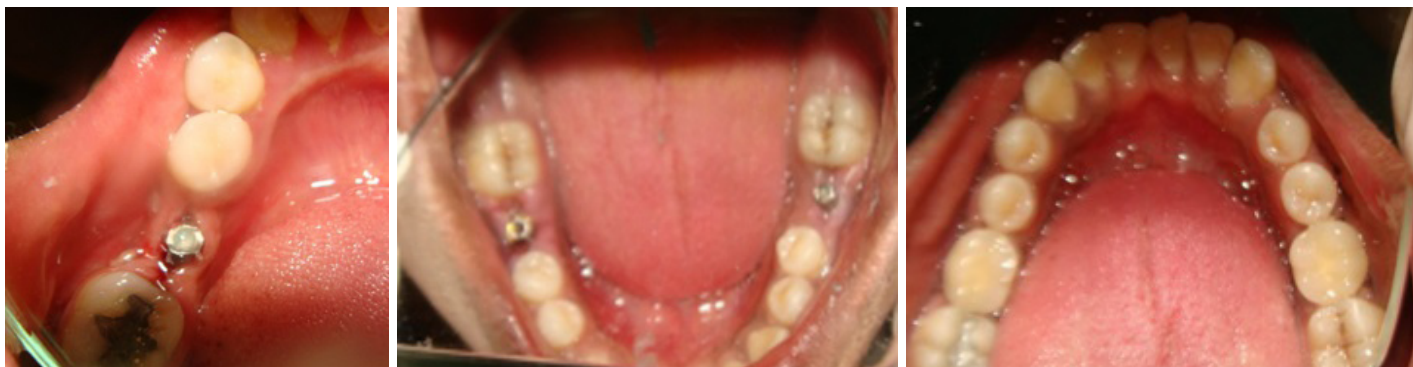
**[Table/Fig-9]:** After removal of cover screw

**[Table/Fig-10]:** After abutment placement

**[Table/Fig-11]:** Restored crown in 36,46
