Ultrastructural Analysis of Incinerated Teeth by Scanning Electron Microscope – A Short Study

Aim: The study was conducted to evaluate the physical and ultrastructural changes seen in freshly extracted teeth when subjected to gradual heating at different temperatures using Scanning Electron Microscope (SEM).

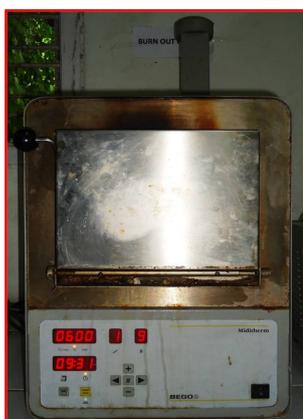
[Table/Fig-1]: Laboratory furnace (Model- BEGO@MIDITHERM) used in the present study. **[Table/Fig-2]:** Scanning electron microscope (Model-HITACHI S-3400N) used in the present study. **[Table/Fig-3]:** Incinerated teeth coated with gold of 600 Å thickness by low vacuum sputter technique for scanning electron microscopy.

i.e., 100°C, 300°C and 600°C respectively for a time of fifteen minutes in laboratory furnace (Model-BEGO- MIDITHERM) [Table/Fig-1], after which they were processed for SEM examination. Each group included 15 teeth; 5 anteriors, 5 premolars and 5 molars. The SEM (Model-HITACHI S-3400N) [Table/Fig-2] analysis was done at NIN, Hyderabad, India over a period of three months.

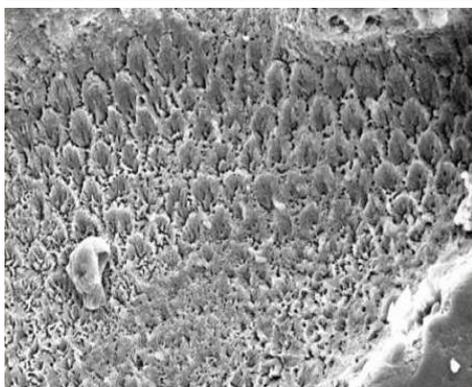
[Table/Fig-4]: The enamel surface of teeth unexposed to heat (Group A) showing characteristic fish scale/keyhole pattern when examined under SEM (1.2 KX). **[Table/Fig-5]:** The enamel surface of teeth exposed at 100°C (Group B) shows enamel rods as pebbles on enamel surface when examined under SEM (1.2 KX). **[Table/Fig-6]:** The enamel surface of teeth exposed at 300°C (Group C) shows enamel rods on enamel surface as granules when examined under SEM (1.2 KX).

Enamel: The enamel surface of teeth unexposed to heat (Group A) when examined under SEM showed characteristic fish scale/keyhole pattern of enamel rods [Table/Fig-4]. At 100°C, there were no significant changes in the morphology of the teeth (Group B). On examination under SEM the characteristic fish scale pattern of enamel rods was lost and instead they appeared as pebbles on enamel surface [Table/Fig-5].

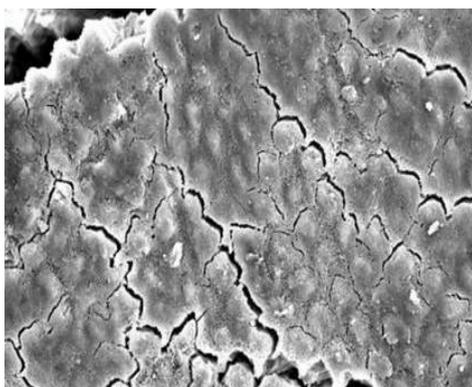
[Table/Fig-7]: The enamel surface of teeth exposed at 600°C (Group D) shows the enamel rods as tiny dots when examined under SEM (1.2 KX). **[Table/Fig-8]:** The root surface of teeth unexposed to heat (Group A) showing characteristic coral pattern when examined under SEM (1.0 KX). **[Table/Fig-9]:** The root surface of teeth exposed at 100°C (Group B) shows characteristic soap bubble pattern when examined under SEM (1.0 KX).

yellow. Under SEM enamel rods on enamel surface appeared as granules [Table/Fig-6]. At 600°C, the color of the teeth (Group D) appeared black like coal, enamel completely came out like a cap and became very fragile. Under SEM surface of enamel showed cracks and the enamel rods appeared as tiny dots [Table/Fig-7]. With increase in temperature the enamel fragments became consistently smaller.

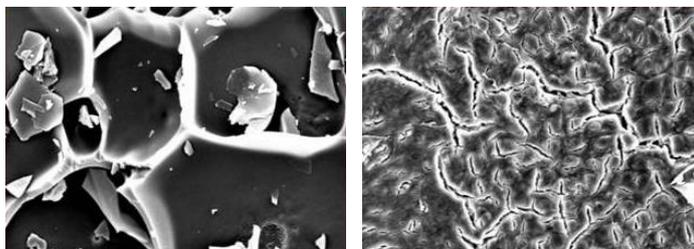
[Table/Fig-10]: The root surface of teeth exposed at 300°C (Group C) shows characteristic honey comb pattern when examined under SEM (1.0 KX).

[Table/Fig-11]: The root surface of teeth exposed at 600°C (Group D) shows characteristic snail track pattern when examined under SEM (1.0 KX).

At 300°C, there were significant changes in the morphology of the teeth (Group C) where the root colour changed to brownish black and under SEM, cementum surface showed the characteristic honey comb pattern [Table/Fig-10]. At 600°C, the color of the teeth (group D) appeared black like a coal and under SEM surface of cementum showed cracks and characteristic snail track pattern [Table/Fig-11].
