Minimally Invasive Restoration of Fractured Maxillary Central Incisors with Partial Laminate Veneers- A Case Series

ASENA KAPTANOGLU¹, TUGCE MERVE ORDUERI², ALAADDIN KILICASLAN³, HALUK BARIS KARA⁴

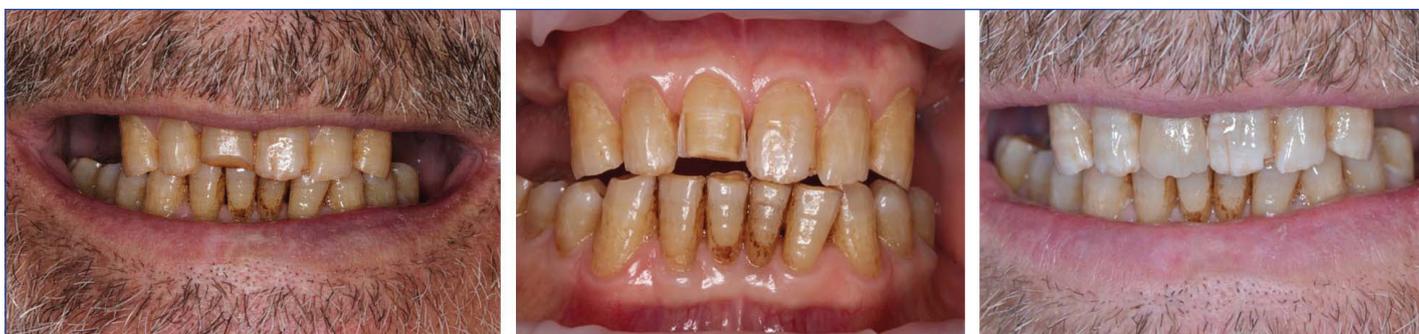
A 73-year-old male patient was referred to the Department of Prosthetic Dentistry. His complaint was the unaesthetic and fractured appearance of his maxillary right incisor due to dental trauma in September, 2018 [Table/Fig-1]. According to clinical and radiographic examination, the tooth was not cariously involved, had no lesions and enlarged periodontal spaces. According to dental trauma guidelines [4], the fracture was uncomplicated crown fracture which had not involved the pulp. Periodontal examination revealed that the patient's oral health was good. The treatment alternatives which include direct composite restorations, partial laminate veneers, laminate veneers, and full crown restorations were

[Table/Fig-1]: Presents fracture at the incisal area at tooth 11; **[Table/Fig-2]:** Preparation of 11 for veneers; **[Table/Fig-3]:** Final view of partial laminate veneer.
Case 1: (Images from left to right)

The preparation was performed with chamfer shaped diamond bur (Hager & Meisinger GmbH, Neuss, Germany). Preparation was performed without bevel in enamel margin integrity in the facial surface. The incisal finish line reduction was performed with butt joint preparation design. Proximal reduction was kept just short of breaking the contact. The preparation was extended to smile line [Table/Fig-2].

The restorations were finished and polished with a no.12 surgical blade and interproximal strips. The occlusion was adjusted with laminate tungsten carbide burs, rugby-ball 40 µm diamond burs, and silicon polishers [Table/Fig-3]. The patient had recall session two weeks after cementation. On 2-weeks follow-up, no changes in the restoration and cementation line were seen.

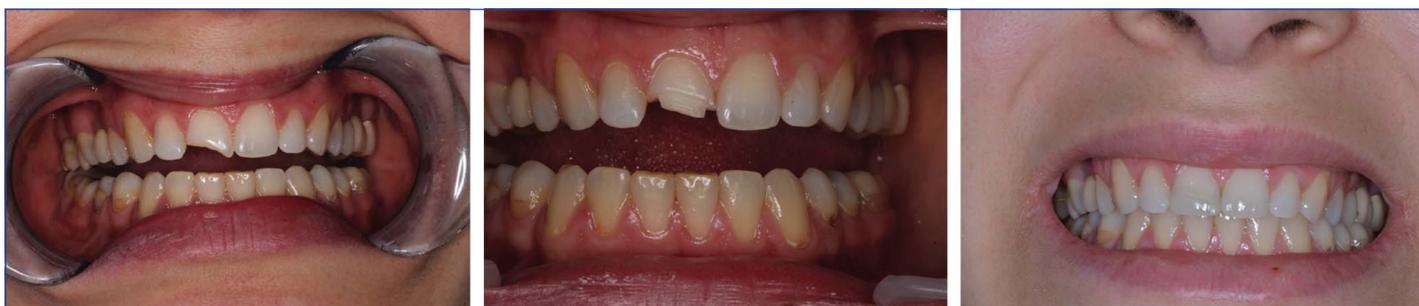
A 32-year-old female patient was referred to the Department of Prosthetic Dentistry, with complaint of fractured maxillary central incisor [Table/Fig-4]. The clinical and radiographic examination revealed that there was no caries lesion. Periodontal examination revealed that the patient's oral health was good. The treatment alternatives which include direct composite restorations, partial laminate veneers, laminate veneers, and full crown restorations were discussed with the patient. Non invasive advantages of partial laminate veneers were presented to the patient and were chosen as the treatment option.

[Table/Fig-4]: Presents fracture at the incisal area at tooth 11; **[Table/Fig-5]:** Preparation of 11 for veneers; **[Table/Fig-6]:** Final view of partial laminate veneer.
Case 2 : (Images from left to right)

The preparation was performed with chamfer shaped diamond bur (Hager & Meisinger GmbH, Neuss, Germany). Chamfer finish line of 0.4 mm maximum depth were made in facial surface. 1.5 mm of incisal reduction was done with palatal chamfer design which included incisal overlap reduction to improve translucency and to provide positive seat for luting. All the internal line angles were rounded to reduce stress in the margins of the veneers. The appropriate tooth reduction was verified with the use of silicone matrix [Table/Fig-5].

The restorations were finished and polished with a no. 12 surgical blade and interproximal strips. The occlusion was adjusted with laminate tungsten carbide burs, rugby-ball 40 µm diamond burs, and silicon polishers [Table/Fig-6]. The patient had recall session

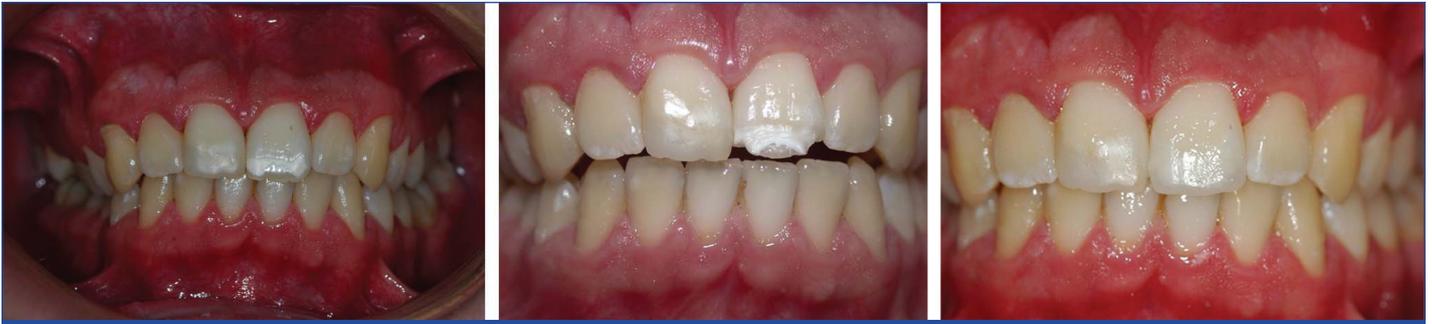
A 21-year-old male was referred to Department of Prosthetic Dentistry. The main complaint of the patient was the white spotted and flecked appearance of the central incisor tooth [Table/Fig-7]. This was because the patient had dental fluorosis. Two main sources of fluoride that likely lead to the increased occurrence of dental fluorosis are greater than 1 ppm in drinking water and dental products containing fluoride (e.g., toothpastes and mouthrinses if swallowed or fluoride supplements) [5]. The clinical and radiographic examination revealed that there was no caries lesion. Periodontal examination revealed that the patient's oral health was good. The treatment alternatives, which include direct composite restorations, partial laminate veneers, laminate veneers, and full crown restorations, were discussed with the patient. It was decided to give partial laminate veneer treatment with ceramic materials.

[Table/Fig-7]: Presents fracture at the incisal area 21; **[Table/Fig-8]:** Preparation of 21 for veneers; **[Table/Fig-9]:** Final view of partial laminate veneer in Case 3. Case 3: (Images from left to right)

The preparation was performed with chamfer shaped diamond bur (Hager & Meisinger GmbH, Neuss, Germany). Chamfer finish line of 0.4 mm maximum depth were made in facial surface. Incisal reduction was done with incisal overlap to improve translucency and to provide positive seat for luting. All the internal line angles were rounded to reduce stresses in the margins of the veneers. The appropriate tooth reduction was verified with the use of silicone matrix [Table/Fig-8].

The restorations were finished and polished with a no.12 surgical blade and interproximal strips. The occlusion was adjusted with laminate tungsten carbide burs, rugby-ball 40 µm diamond burs, and silicon polishers [Table/Fig-9]. The patient had recall session two weeks after cementation. The restored teeth was healthy at 2-weeks follow-up.
