Repositioning of Misplaced Central Venous Catheter with Saline Injection Under C-Arm Imaging

PARSHOTAM LAL GAUTAM¹, SANDEEP KUNDRA², KRISHAN JAIN³, HITIKA MONGA⁴

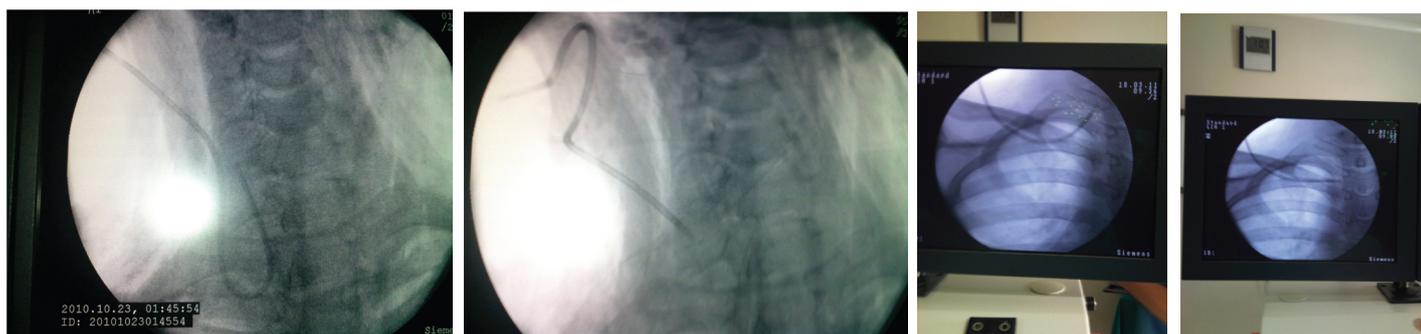
[Table/Fig-1]: CVC coiled upon itself in the IJV, [Table/Fig-2]: Misplaced CVC getting corrected by the use of saline push, [Table/Fig-3]: Misplaced subclavian venous catheter entering ipsilateral IJV, [Table/Fig-4]: Misplaced CVC being corrected

A 55-year-old male patient was admitted with acute pyelonephritis & had difficult venous access. So decision was taken to insert central line for intravenous (IV) access & central venous pressure (CVP) monitoring. Initial trial of central line insertion in ward had failed so plan was made to insert central line under ultrasound guidance. After standard aseptic precautions, under ultrasound guidance, right internal jugular vein (IJV) was pierced with 16 G cannula, guide wire inserted and right IJV cannulated with a double lumen catheter using Seldinger's technique. Increased resistance was felt while removing the guide wire; however, blood could be aspirated from both ports of the catheter. Post procedure chest X-ray revealed that central line was lying in Right IJV but coiled on itself like a hair pin [Table/Fig-1]. We decided to reposition the central line using hydrostatic method under fluoroscopic guidance. Patient was taken to operation table; neck was painted with povidone iodine & sterile draping done. Sutures holding the central venous catheter (CVC) were removed & catheter withdrawn by 5cm under C-arm guidance. Then a syringe containing 10ml of normal saline was connected to the 16 G lumen & a sudden push of saline was given & this was repeated four times. After each saline push, the central line tip was visualized under C-arm. We could see the U-turn of central venous catheter straightening with each saline push [Table/Fig-2]. When the catheter had fully straightened, it was inserted another 6cm and fixed at 12cm at skin level and the tip of central line could be visualized just above superior vena cava. Blood could be aspirated from both ports.

A 12-year-old male was planned for central line re-insertion because the previous CVC got dislodged accidentally. Left sided subclavian vein (SCV) was cannulated using Seldinger's technique, guide wire was removed and blood aspirated from both ports. However, post procedure chest X-ray revealed that the tip of catheter had gone into the left internal jugular vein [Table/Fig-3]. Plan was made to reposition the central line using hydrostatic method. After painting & sterile draping, sutures holding the central venous catheter was removed & catheter withdrawn by 4cm. A 10cc syringe filled with Normal saline was connected to 16 G port and sudden push of saline given, this was repeated 5 times and we could visualize the catheter to be straightening [Table/Fig-4]. Then the catheter was inserted without inserting guide wire and the tip visualized in superior vena cava under C-arm guidance.

We describe a new method of an old technique that uses forceful saline injection under image intensifier for correction of malpositioned CVC [12]. In this technique, first catheter is withdrawn under aseptic conditions to a favorable position and then a force is given using jet of saline to straighten the bend in the central line. After straightening the catheter, we reinserted & repositioned the CVC under fluoroscopic guidance and visualized the tip in SVC. Misplacement into both IJV and subclavian vein can be corrected using this technique.
